Montgomery County Fire and Rescue Service

POST INCIDENT ANALYSIS

**2nd Alarm House Fire
203 2nd Avenue
Washington Grove, MD**

Incident Date: January 14, 2014

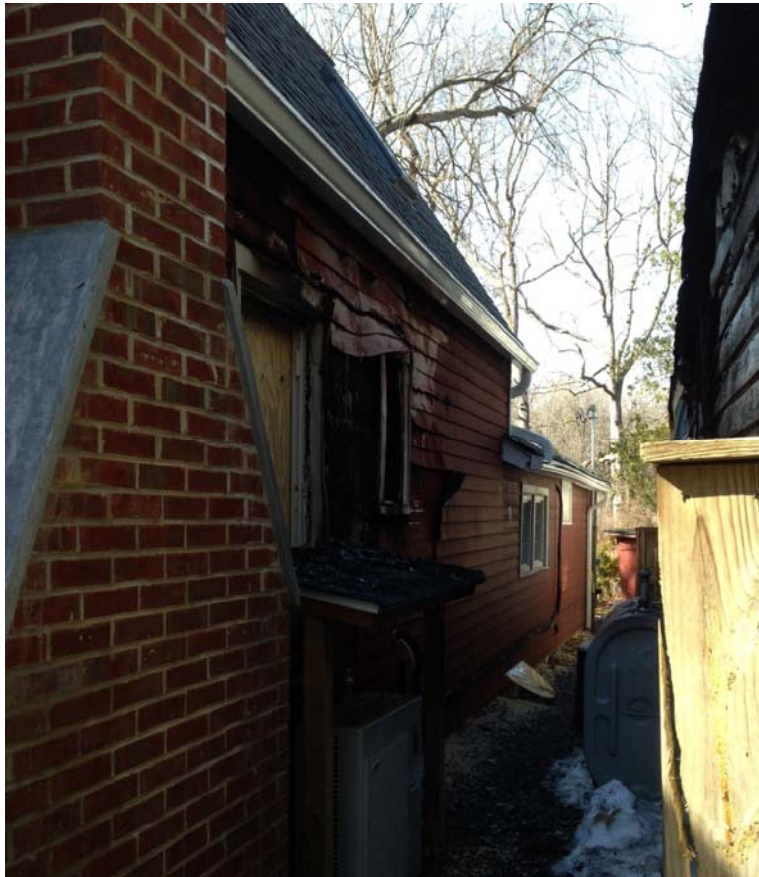
Image of Exposure Bravo – showing separation between houses & melted siding

Exposure Bravo is a 2 story Type V wood framed single family separated from 203 2nd Avenue by about 6 feet.

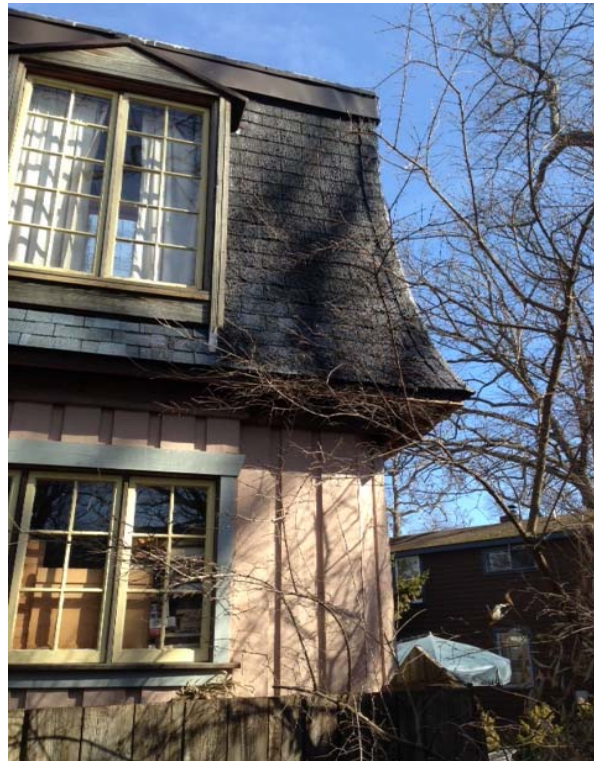
Image of Exposure Delta with melted shingles

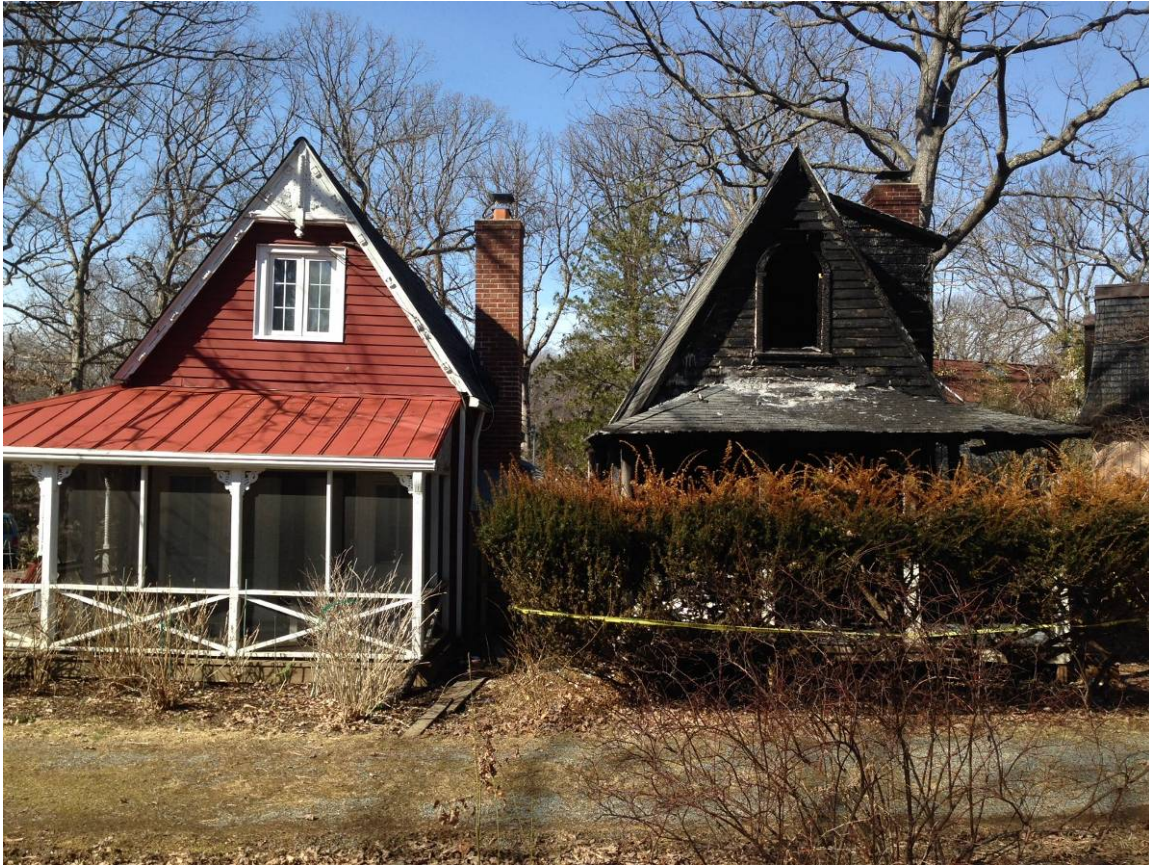
MCFRS Fire and Explosives Investigators responded to the incident and began their investigation; however, due to the fire damage to the supporting structures on Side Alpha and in Quadrants Alpha & Delta, the investigators were unable to complete their investigation and determine origin or cause. The cause remains listed as “undetermined”.

Image of Side Alpha

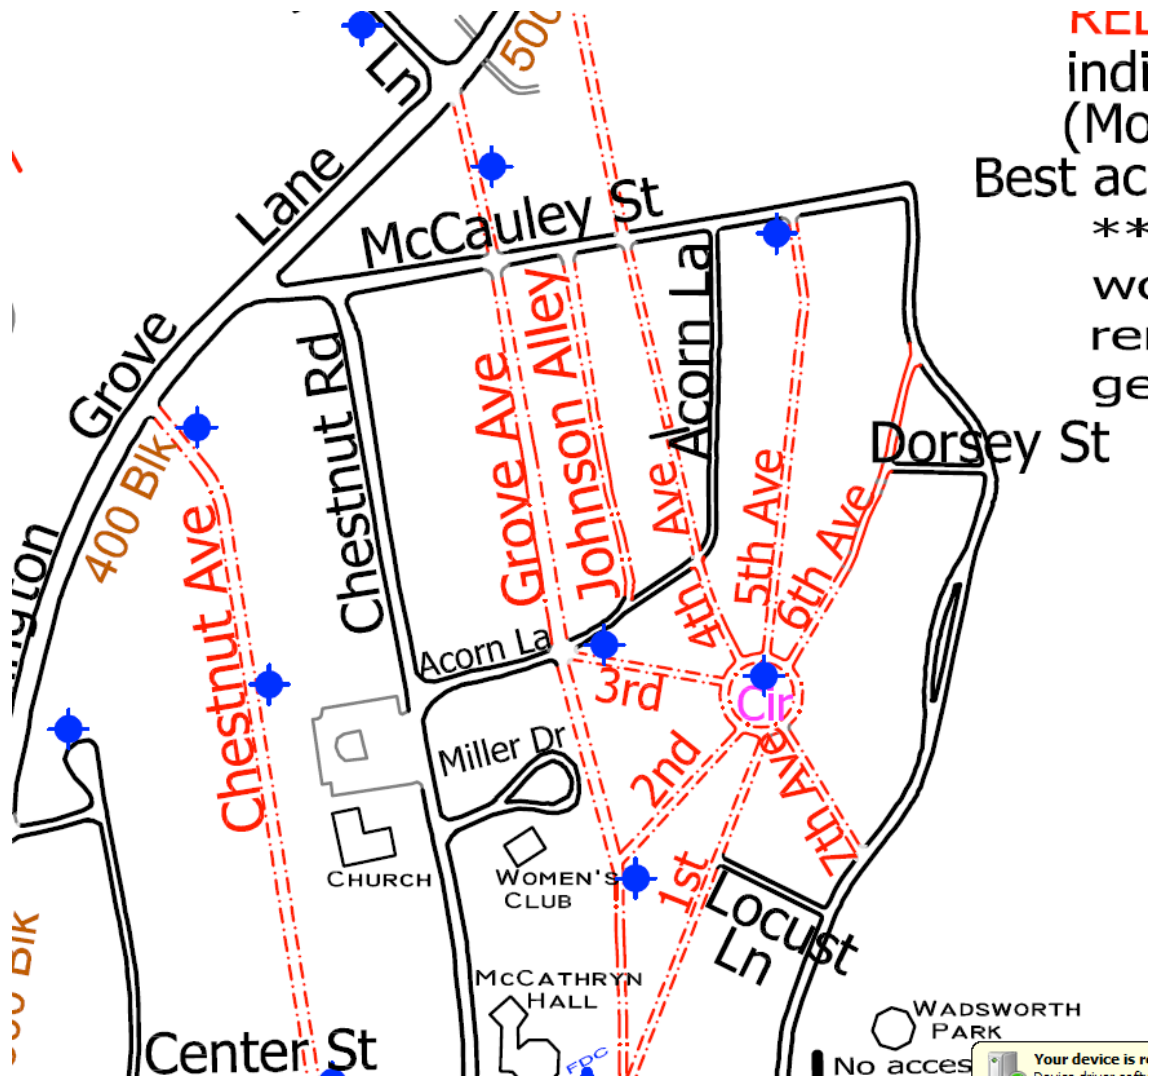
Section from Map 8-323

- c. Station street maps did not adequately distinguish paved roads from walking paths.
- d. A majority of key hydrants were located on unpaved walking paths which apparatus could not access easily.

1. The station maps have been updated to reflect:
 - a. Paved roads verses unpaved walking paths
 - b. The walkway signs can be removed to facilitate access to homes
2. Location information is being added to the Computer Aided Dispatch database to provide specific access instructions to responding units
3. MCFRS has met with Washington Grove Community leaders to recommend:
 - a. Street Signs be changed from small wooded signs to standard metal street signs
 - b. Residents affix address numbers and street names to individual homes
 - c. Reflective disks or tape be affixed to street sign posts, as well as walkway posts
 - d. Instructions be placed on the walkway posts to assist first responders with removing these posts to gain better access to the community in the event of an emergency
 - e. Reflective metal posts be placed at all hydrates in the Washington Grove community

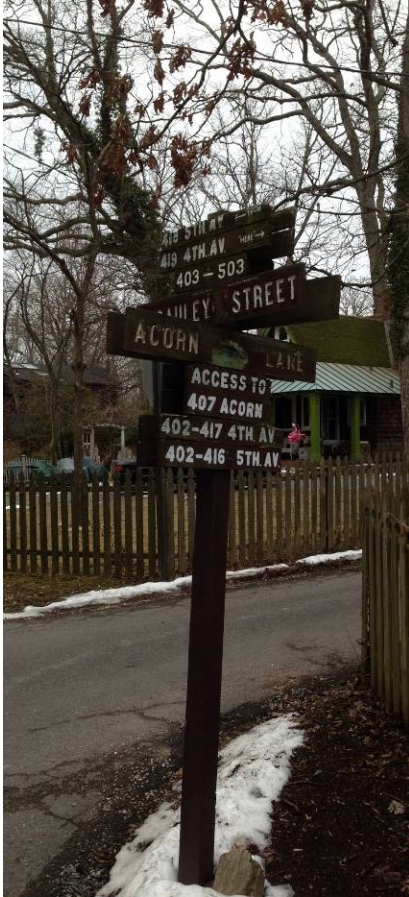
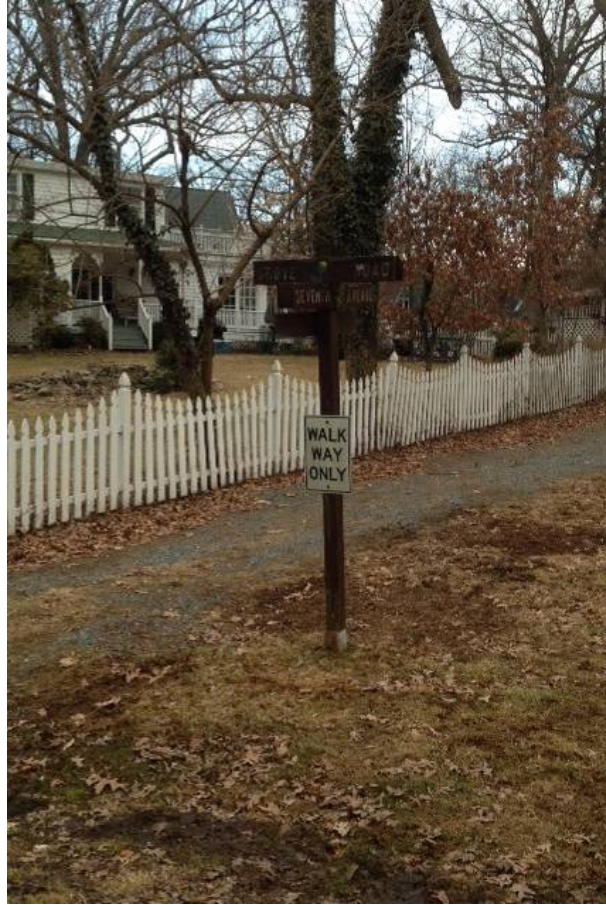
1. Units had a difficult time locating the incident and navigating their way in Washington Grove
 - a. Street signs were small and difficult to see; wooden signs with white lettering on brown background.

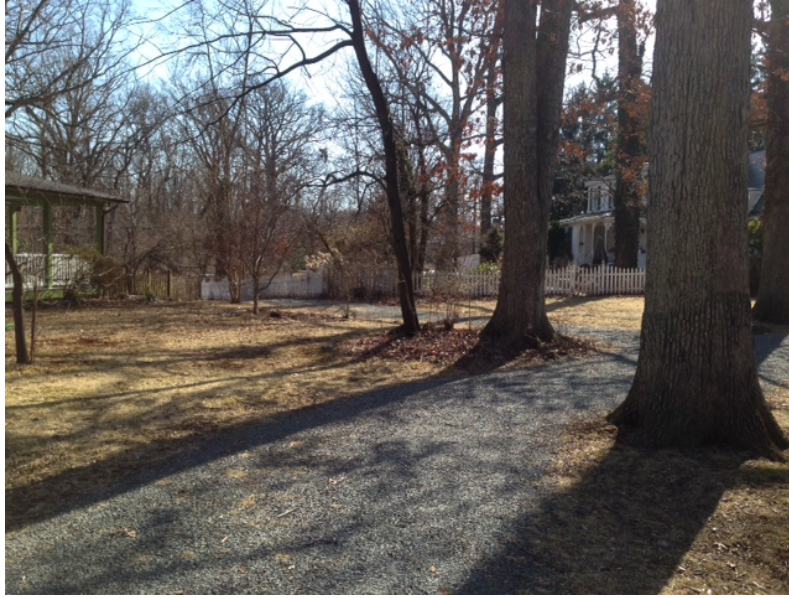
- b. Many streets in the neighborhood are narrow unpaved walking paths that apparatus could not traverse.
